Governor Mario M. Cuomo Bridge

Pavement Condition Report Appendices

**NONDESTRUCTIVE EVALUATION (NDE) INVESTIGATION
ROSPHALT OVERLAID BRIDGE DECK CONDITION ASSESSMENT
SONIC SURFACE SCANNER – IMPACT ECHO AND SPECTRAL ANALYSIS OF SURFACE
WAVES TESTING (S³-IE/S³-SW)
SHARED USE PATH AND MAIN LANES OF GOVERNOR MARIO M. CUOMO BRIDGE
I-287 THRUWAY OVER THE HUDSON RIVER
NEW YORK STATE THRUWAY AUTHORITY
TARRYTOWN, NEW YORK**

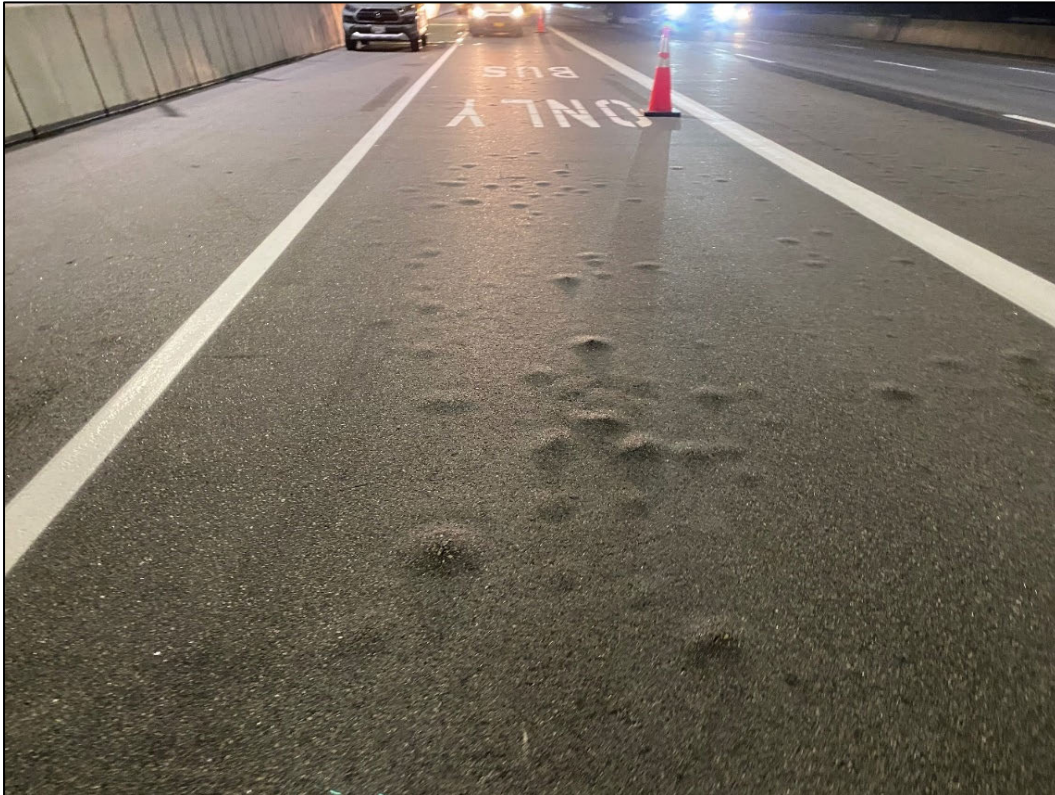
Figure 1. The “blisters” in question. Blisters are typically 4 to 8 inches and diameter and are observed throughout the bridge; however, the frequency of blisters varies from span to span.

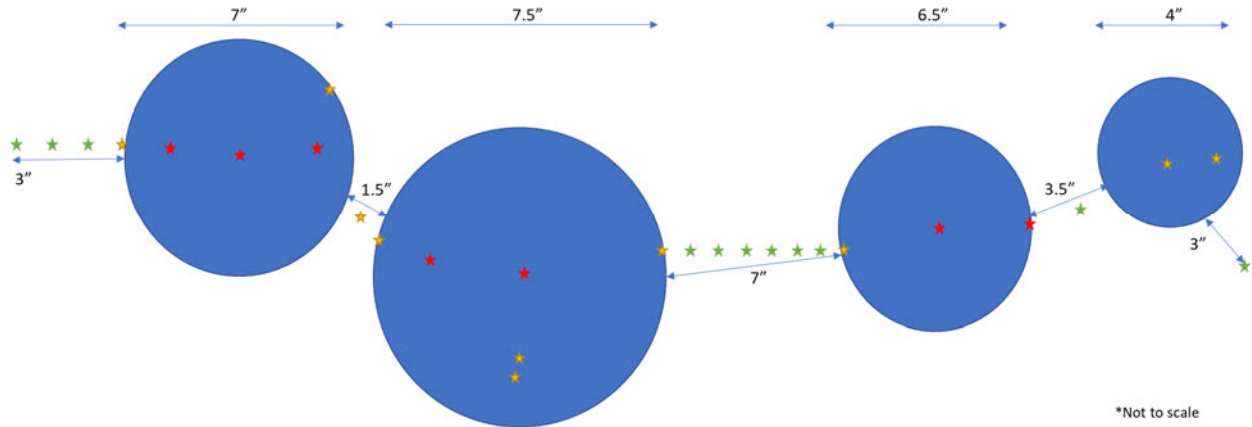
Figure 5. Schematic showing the approximate location and size of blisters shown in Figure 4 and test points, color coded by result. Green points indicate a “sound” condition, yellow points indicate a “questionable condition, and red points indicate a “poor” condition.

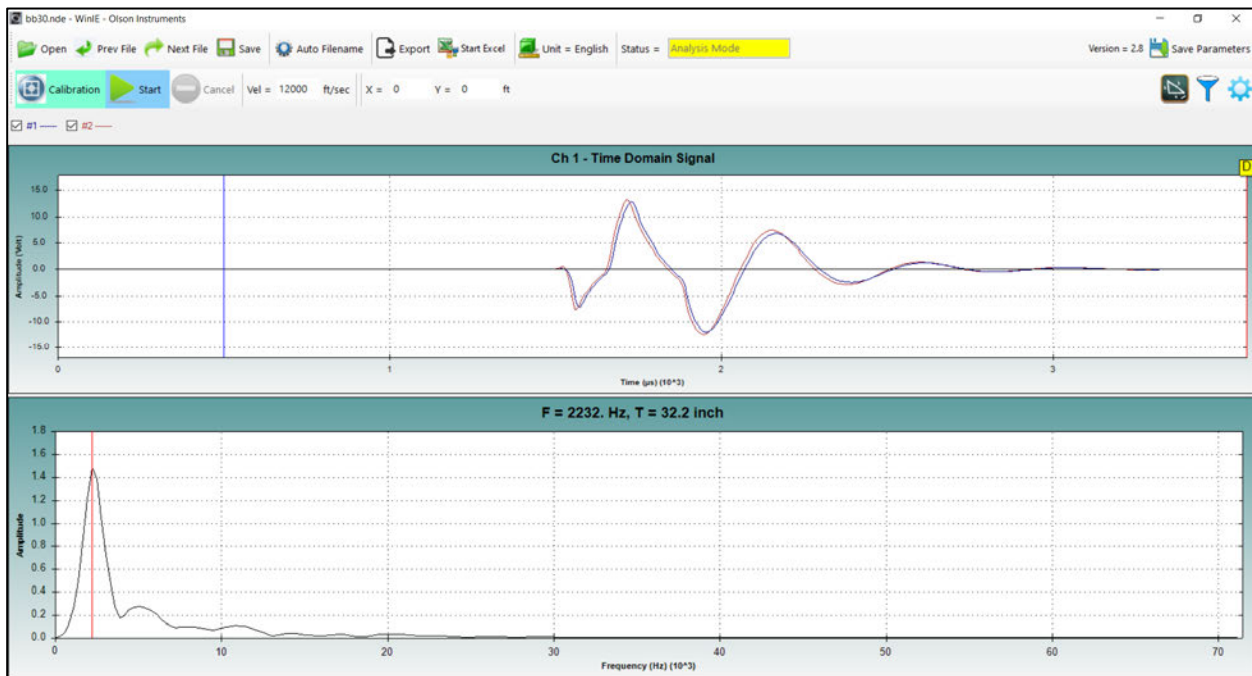
Figure 6. IE result from the center of a blister showing a high-amplitude, low-frequency echo marked by the vertical cursor at 2232 Hz in the bottom plot that corresponds to a high apparent thickness echo (32.2 inches – flexural resonance). Classified as “Poor” debonded, blistered condition. The top plot is the voltage response to the impact of the displacement transducer versus time from which FFT calculations produced the bottom linear frequency displacement spectra plot.

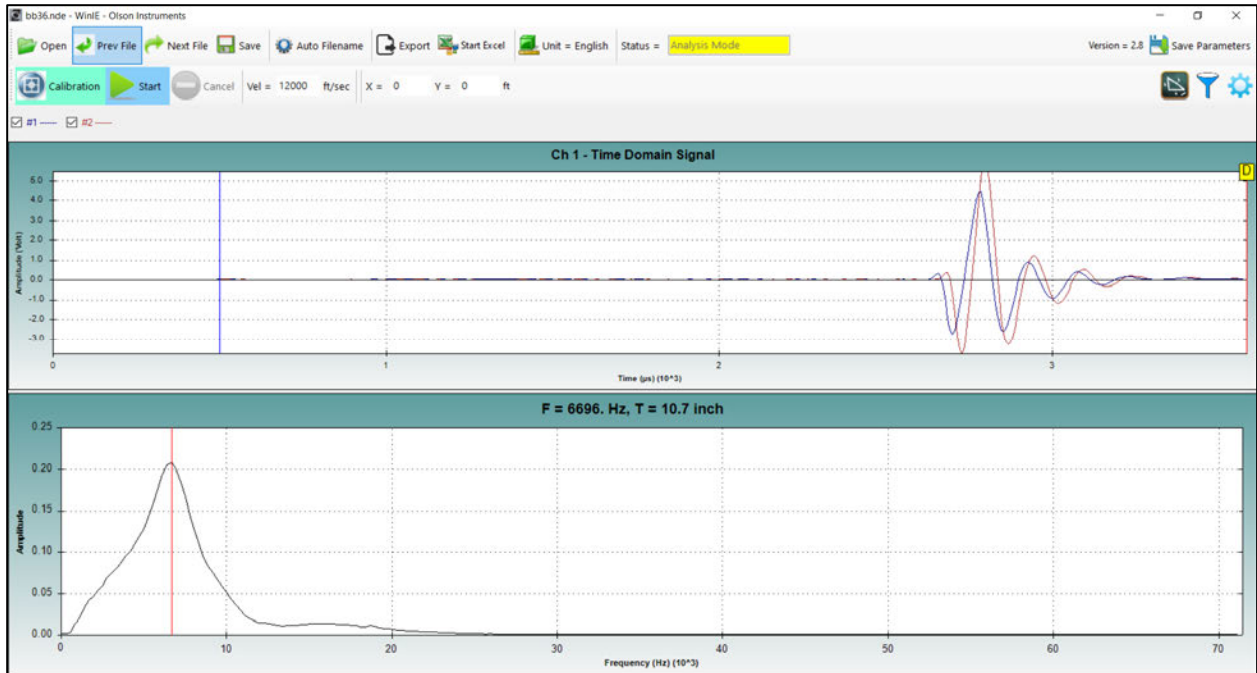
Figure 7. IE result from 2 inches off the edge of a blister that shows a typical result for “Sound” conditions with a calculated thickness matching the expected deck thickness (10.7 inches).

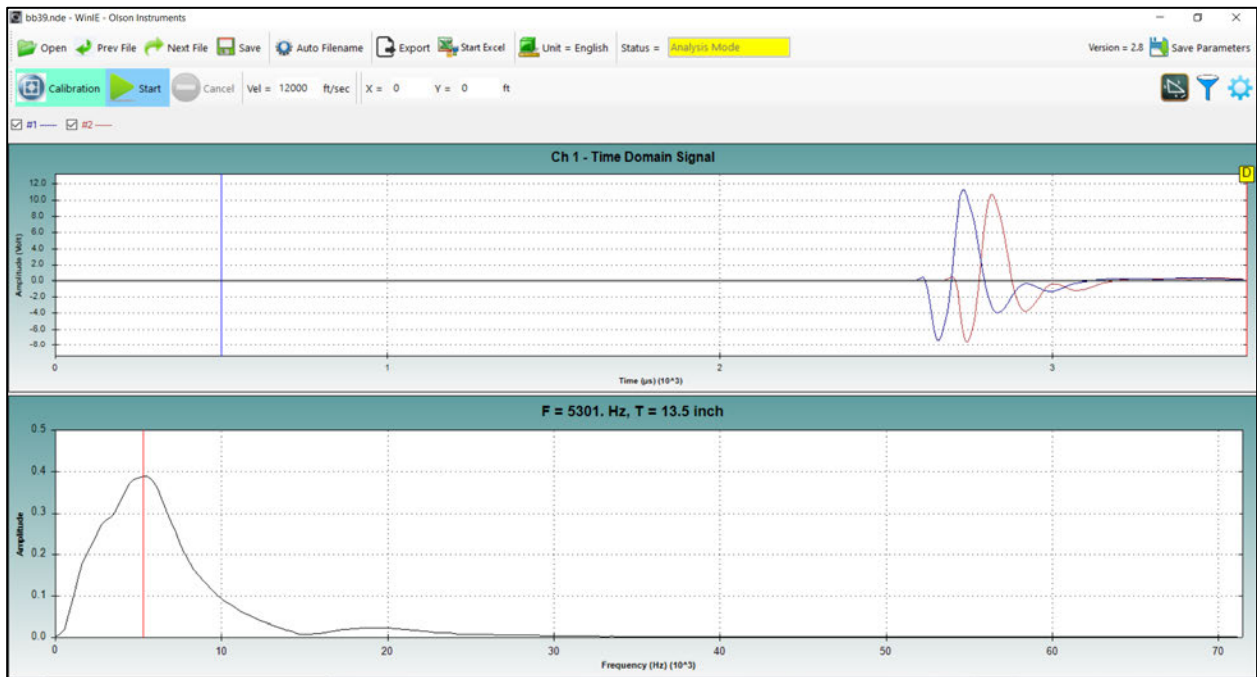
Figure 8. IE result from the edge of a blister. The slightly thick IE result (13.5 inches) indicates “Questionable” Rosphalt bonding conditions.

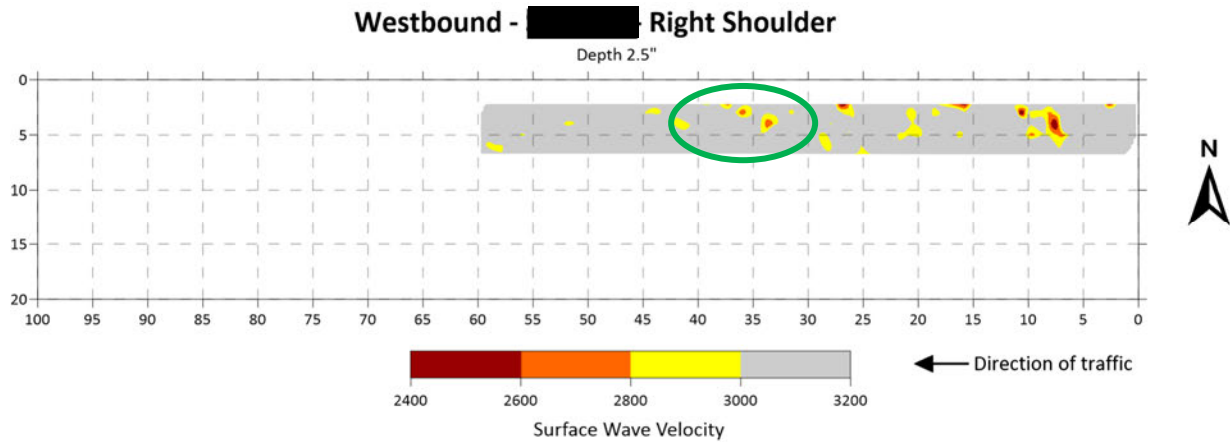
Figure 9. S³ - SASW Results of Westbound [redacted] Right Shoulder and Lane (partial). Y = 0 is at north barrier wall, X = 0 is at lamp post 17 with X increasing to the west. The green oval notes the area of significant blisters visually noted from X = 31 – 42 feet and Y = 2 – 6 feet. Slower velocities were expected to correspond to areas of blisters in the SASW results.

As presented in Figure 9, the Sonic Surface Scanner results of the SASW data analyses did not clearly indicate the area of a noted high concentration of blisters, whereas the IE analyses did (Figure 10). This evaluation was based on noted visual observations, as well as detailed analysis of each data point within the comparison area, where the blister signature was obvious in the IE analysis and agreed well with field notes. In general, the surface wave wavelengths of less than 1.5inches (the thickness of the fairly hard Rosphalt) were difficult to excite; therefore, the SASW information typically started right at the depth of the Rosphalt/Concrete interface or below, making the Rosphalt difficult to evaluate. Also, based upon the point-by-point study, it is likely that SASW testing on the blisters resulted in non-coherent data due to the delamination type vibratory response, and was thrown out during the analysis process. Thus, blister locations were removed from the dataset because an accurate dispersion curve could not be calculated.

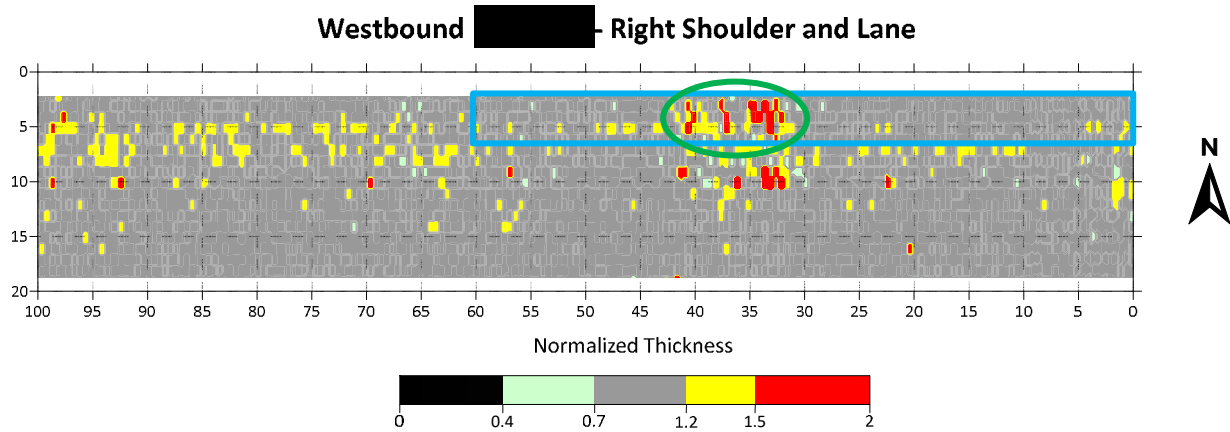
Figure 10. S³-IE Results of Westbound [redacted] Right Shoulder and Lane – comparison area in blue box. Y = 0 is at north barrier wall, X = 0 is at lamp post 17 with X increasing to the west. The green oval notes the area of significant (high-frequency) blisters visually noted from X = 31 – 42 feet and Y = 2 – 6 feet. As discussed further below in Section 3.2, red denotes a blister, yellow is an incipient/smaller blister, gray is normal bonded deck area, light green is a shallow echo not associated with blistering and black is an embedded feature such as metal scuppers, steel expansion joints, etc.

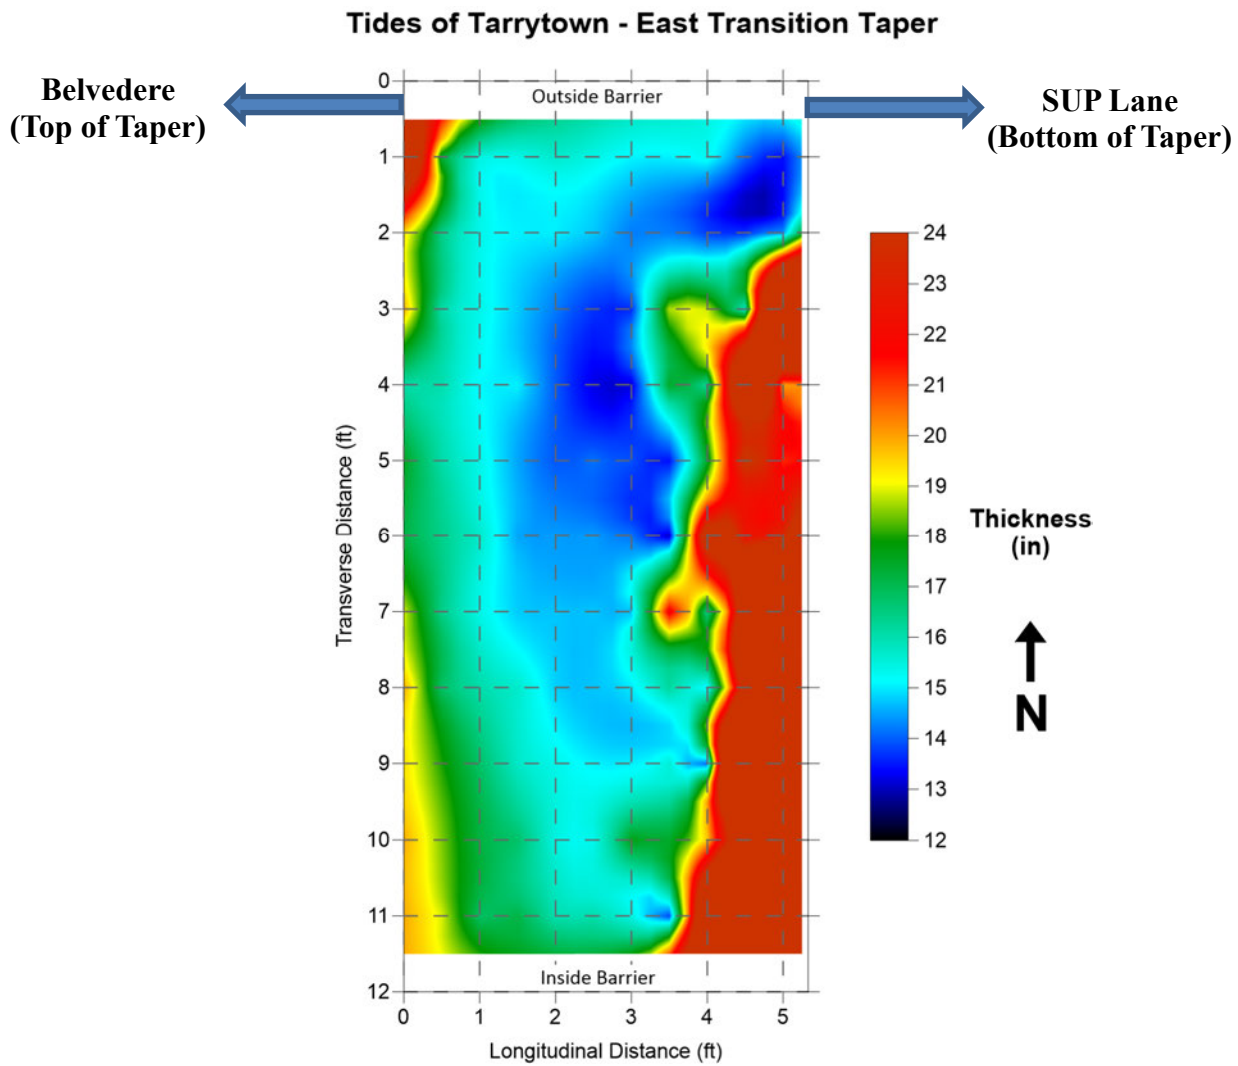
Testing using the S³-IE system was also performed on both ‘Tides of Tarrytown’ Belvedere #6 concrete transition tapers. The testing was performed on a 1-foot transverse spacing across the full lane width (scans from 1 to 11 feet). The tapers were measured to be 5’4” in length. The total concrete thickness (taper and bridge deck) was found to be approximately 20 inches at the top of the taper and sloping to approximately 13.5 inches at the taper toe. Delaminations/debonds typically create low frequency, higher amplitude vibrations (flexural resonance) that result in an apparent thickness increase of the section. Therefore, the debonded areas register as thicker than the maximum belvedere transition thickness (>20 inches) and are shown as red in the results figures below. The S³-IE results indicate extensive delamination of both concrete tapers from the concrete bridge deck. The delaminations are concentrated at the ‘toe’ (thinnest) of the tapers. Figure 12 presents a simulated example of the expected tapers test results for sound deck conditions, while Figures 13 and 14 present the measured data from the East and West tapers, respectively, which shows extensive delamination of both concrete tapers.

Figure 13. S³-IE Results of Tides of Tarrytown Belvedere #6 East transition taper. X = 0 is at the top of the taper, Y = 0 (top) is at the North outside barrier wall. The red areas (increased apparent thickness due flexural resonance from the debond) indicate the approximate area of significant delamination.
