Governor Mario M. Cuomo Bridge

Pavement Condition Report

Written by John Bors

February 2021

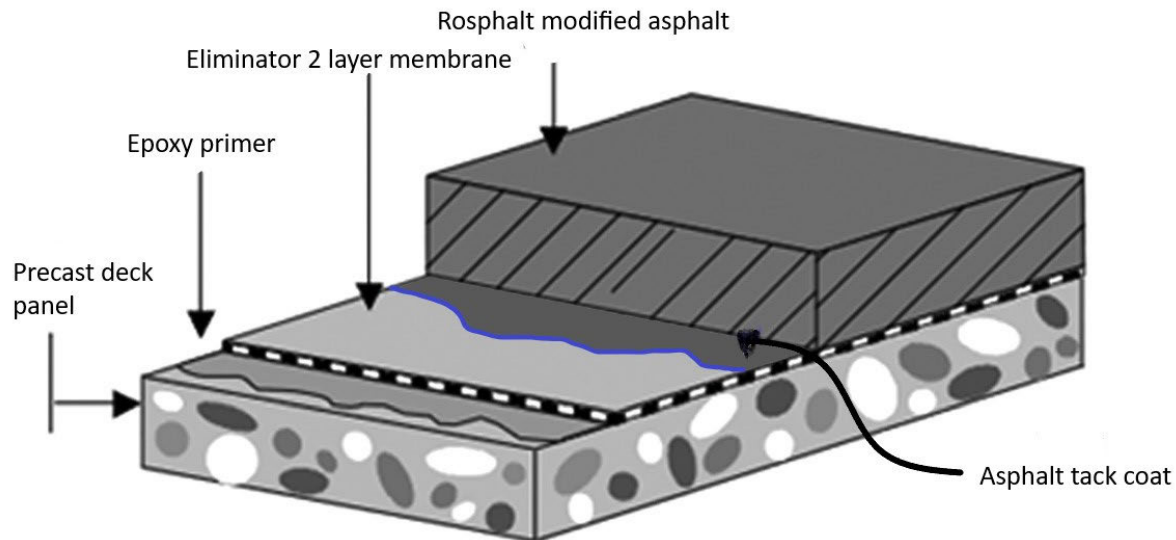
This report offers a preliminary condition survey focused on paving surface defects consisting of slightly elevated, circular raised mounds or blisters observed on the pavement surface. The blisters became a concern when the SUP was being prepared for its opening in late 2019. Similar blisters have been observed on the shoulders and roadways of both the EB and WB structures.
