Governor Mario M. Cuomo Bridge

Pavement Condition Report Appendices

**NONDESTRUCTIVE EVALUATION (NDE) INVESTIGATION
ROSPHALT OVERLAID BRIDGE DECK CONDITION ASSESSMENT
SONIC SURFACE SCANNER – IMPACT ECHO AND SPECTRAL ANALYSIS OF SURFACE
WAVES TESTING (S³-IE/S³-SW)
SHARED USE PATH AND MAIN LANES OF GOVERNOR MARIO M. CUOMO BRIDGE
I-287 THRUWAY OVER THE HUDSON RIVER
NEW YORK STATE THRUWAY AUTHORITY
TARRYTOWN, NEW YORK**

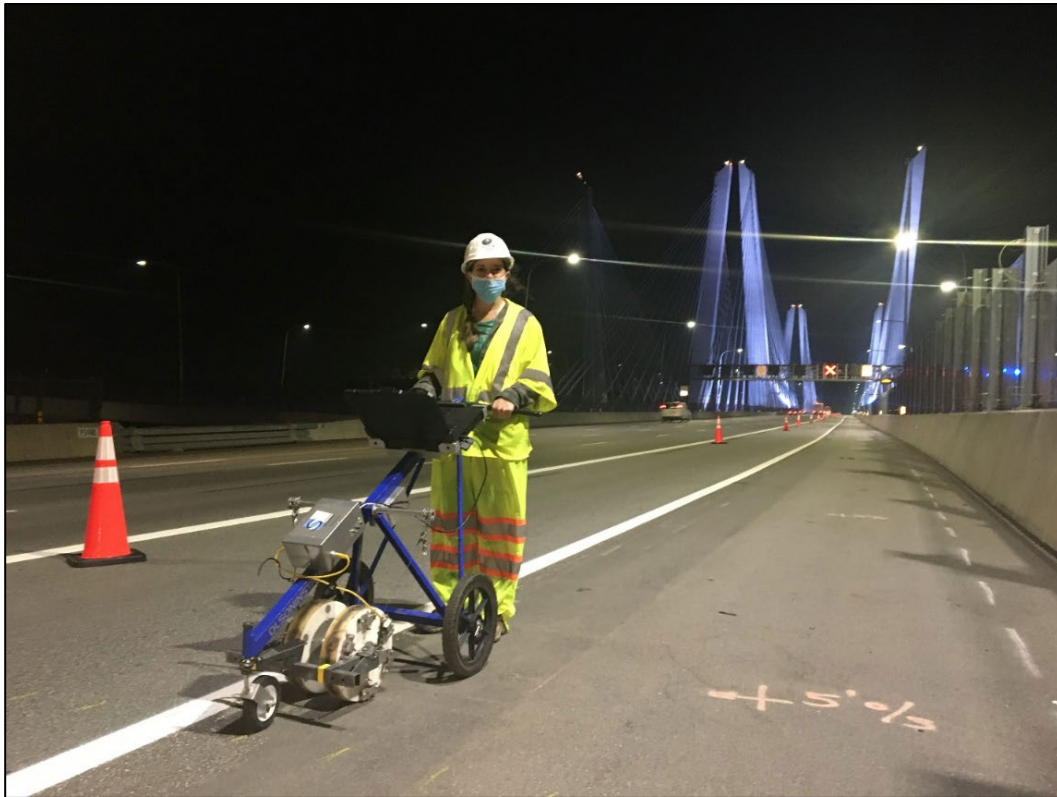
Figure 2. Photo of the S³-IE/SW transducer wheels, cart and computer for data acquisition on the Westbound structure. Note that the transducer wheels are spaced 6 inches apart with an IE test on the right wheel and SASW tests between the two wheels simultaneously conducted every 6 inches along the scan lines as the cart was slowly walked along the bridge deck.

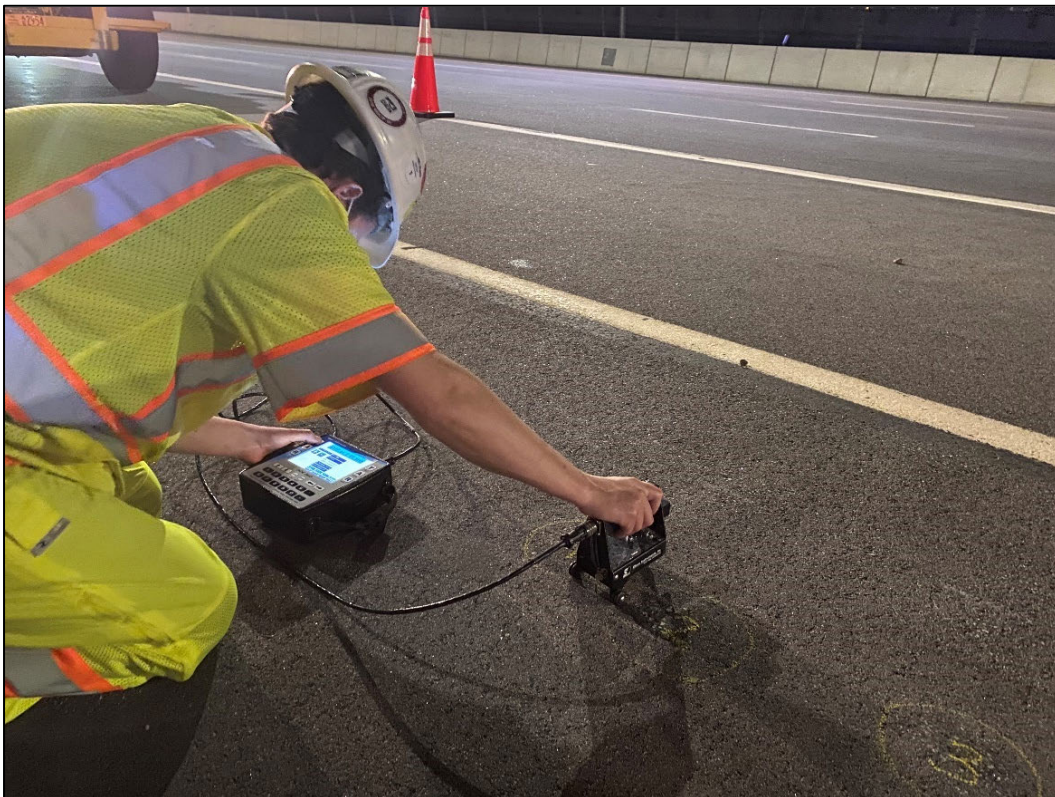
Figure 3. IE testing on individual blisters with an Olson Instruments NDE 360 data acquisition system and IE-1 test head.

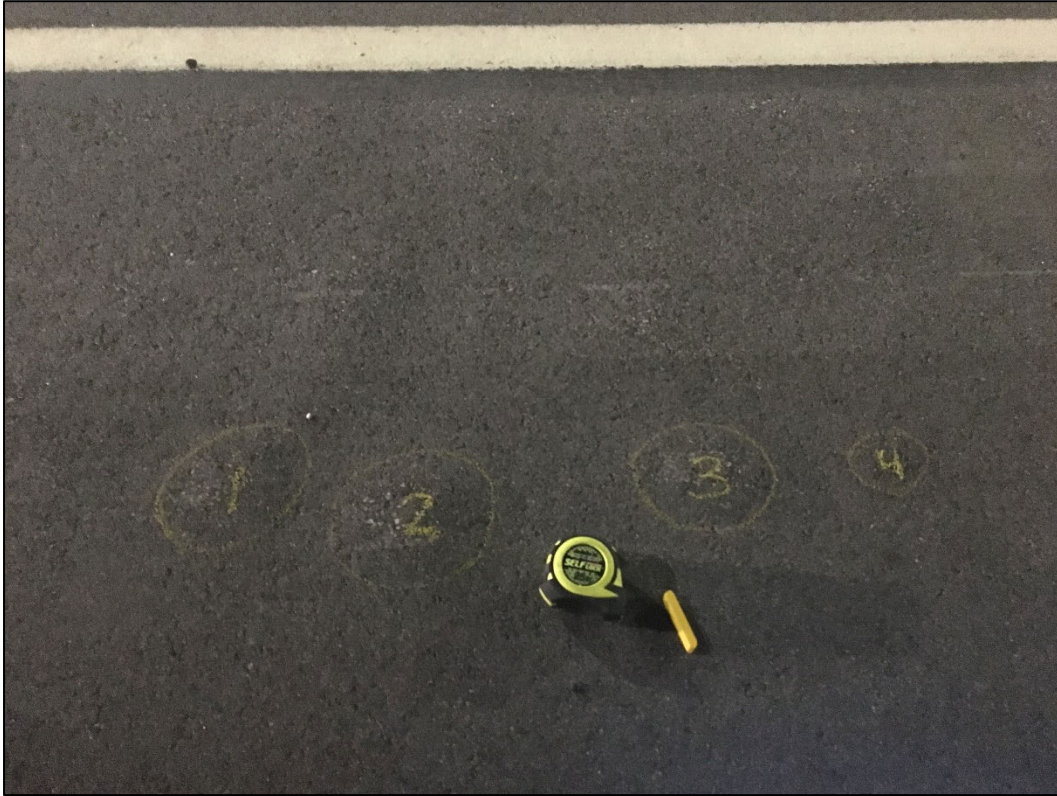
Figure 4. Photograph of group of 4 blisters evaluated with point-by-point IE and SASW testing in the eastbound right shoulder.

The point-by-point IE results clearly illustrate that the IE method is effective at detecting the blister anomalies. The results indicate that larger blisters (6+” diameter) will have a much different signature than Sound Rosphalt/concrete deck (bonded) condition areas, with a resonant frequency significantly lower than expected for blisters (calculated thickness change from 10.7 to 32.2 inches or 201% increase in these examples). The data also shows that tests on small blisters (4” diameter or less), at the edge of blisters, and the area between closely spaced blisters will have a discernable increase in calculated thicknesses (calculated thickness change from 10.7 to 13.5 inches or 26.2% increase in these examples). While testing on the centers of the larger blisters (presumably the highest part of the defect) yielded consistent “Poor” results, the height of the blister does not seem to affect detection/condition-rating as much as the diameter of the blister and/or the proximity of the test to the edge of the blister. The point-by-point IE testing confirmed the field analysis of the S³-IE data, which also indicated that the IE test method was capable of identifying the blisters when the blisters were directly tested on with the rolling Sonic Surface Scanner.

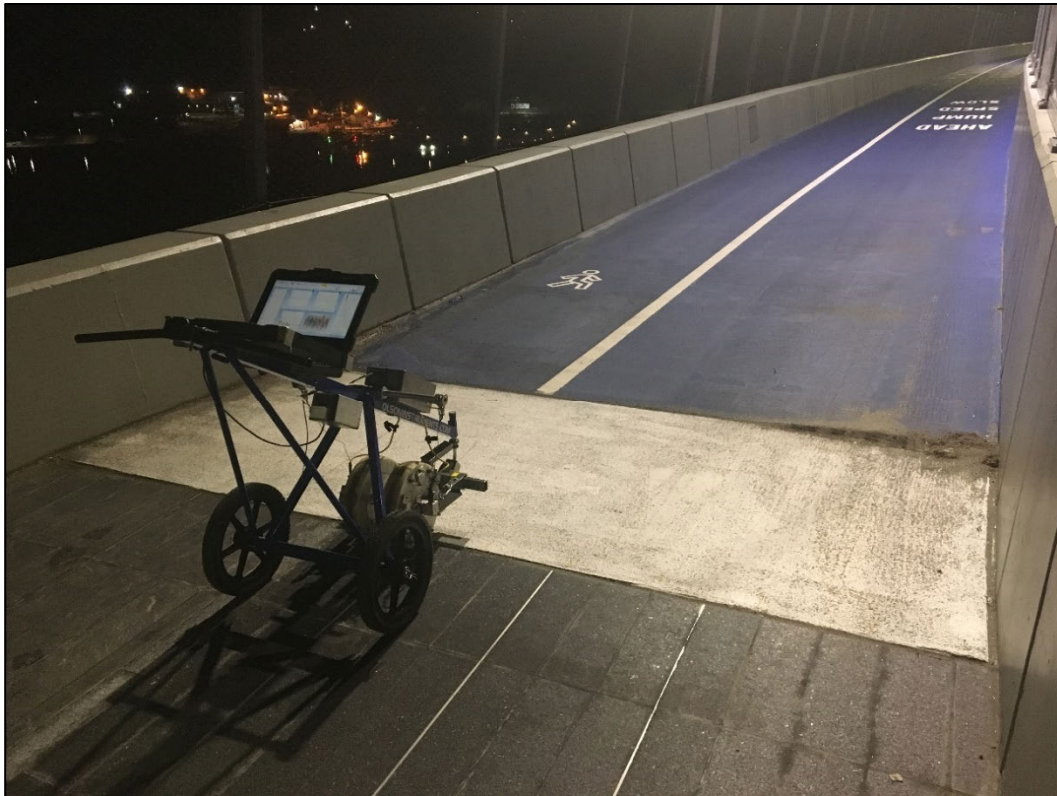
Testing using the S³-IE system was also performed on both ‘Tides of Tarrytown’ Belvedere #6 concrete transition tapers. The testing was performed on a 1-foot transverse spacing across the full lane width (scans from 1 to 11 feet). The tapers were measured to be 5’4” in length. The total concrete thickness (taper and bridge deck) was found to be approximately 20 inches at the top of the taper and sloping to approximately 13.5 inches at the taper toe. Delaminations/debonds typically create low frequency, higher amplitude vibrations (flexural resonance) that result in an apparent thickness increase of the section. Therefore, the debonded areas register as thicker than the maximum belvedere transition thickness (>20 inches) and are shown as red in the results figures below. The S³-IE results indicate extensive delamination of both concrete tapers from the concrete bridge deck. The delaminations are concentrated at the ‘toe’ (thinnest) of the tapers. Figure 12 presents a simulated example of the expected tapers test results for sound deck conditions, while Figures 13 and 14 present the measured data from the East and West tapers, respectively, which shows extensive delamination of both concrete tapers.

Figure 11. Transition taper at Belvedere #6 showing the S³-IE system at X=0 (top of the taper, West). Scans run West to East down the taper.

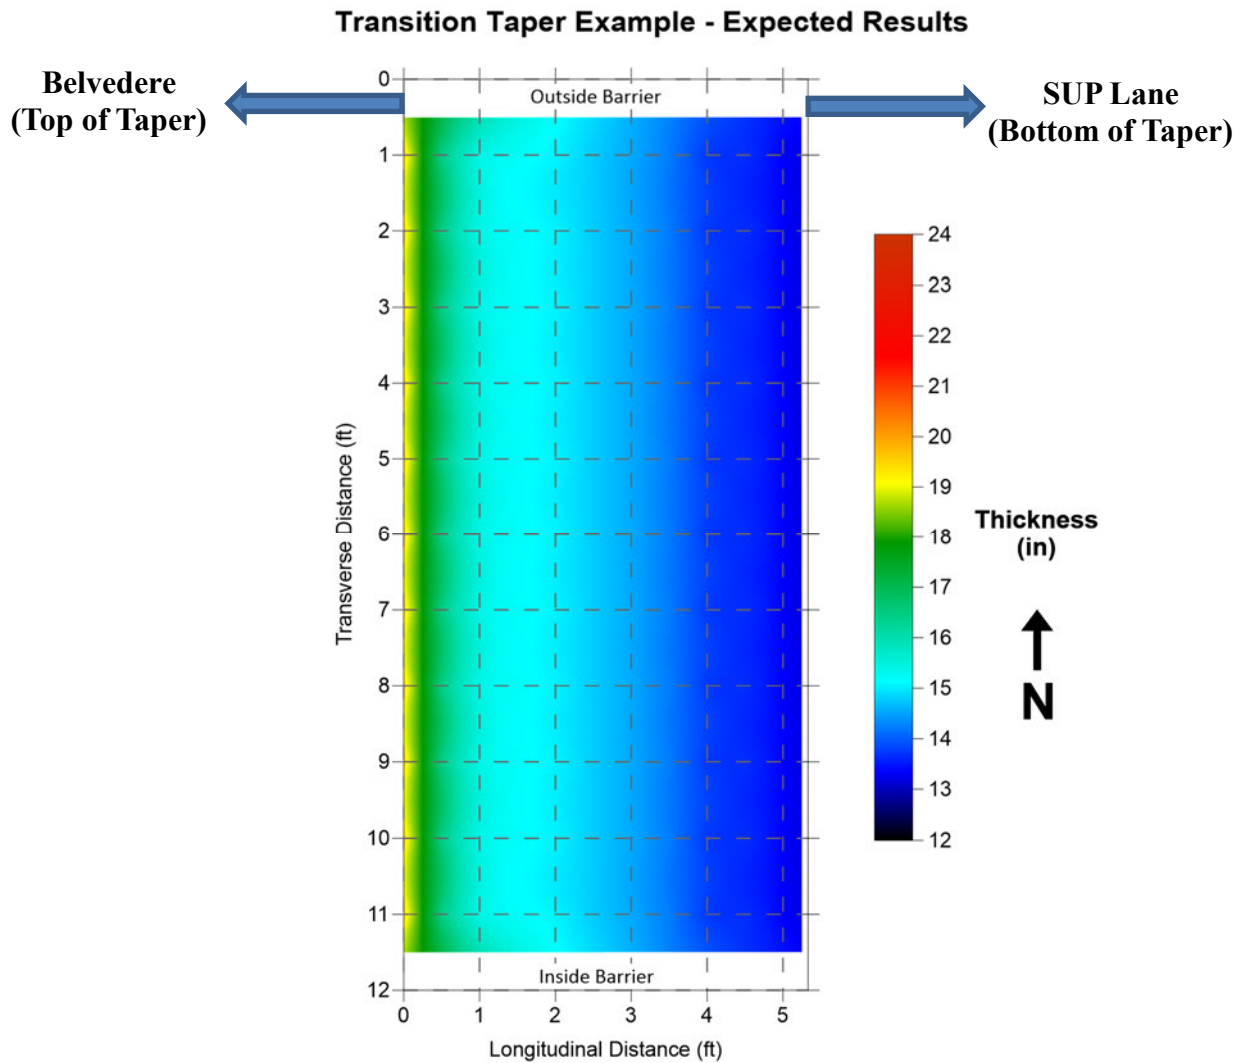
Figure 12. Simulated S³-IE Results of a Belvedere #6 transition taper to illustrate the expected results for sound deck conditions. X = 0 is at the top of the taper, Y = 0 (top) is at the North outside barrier wall.

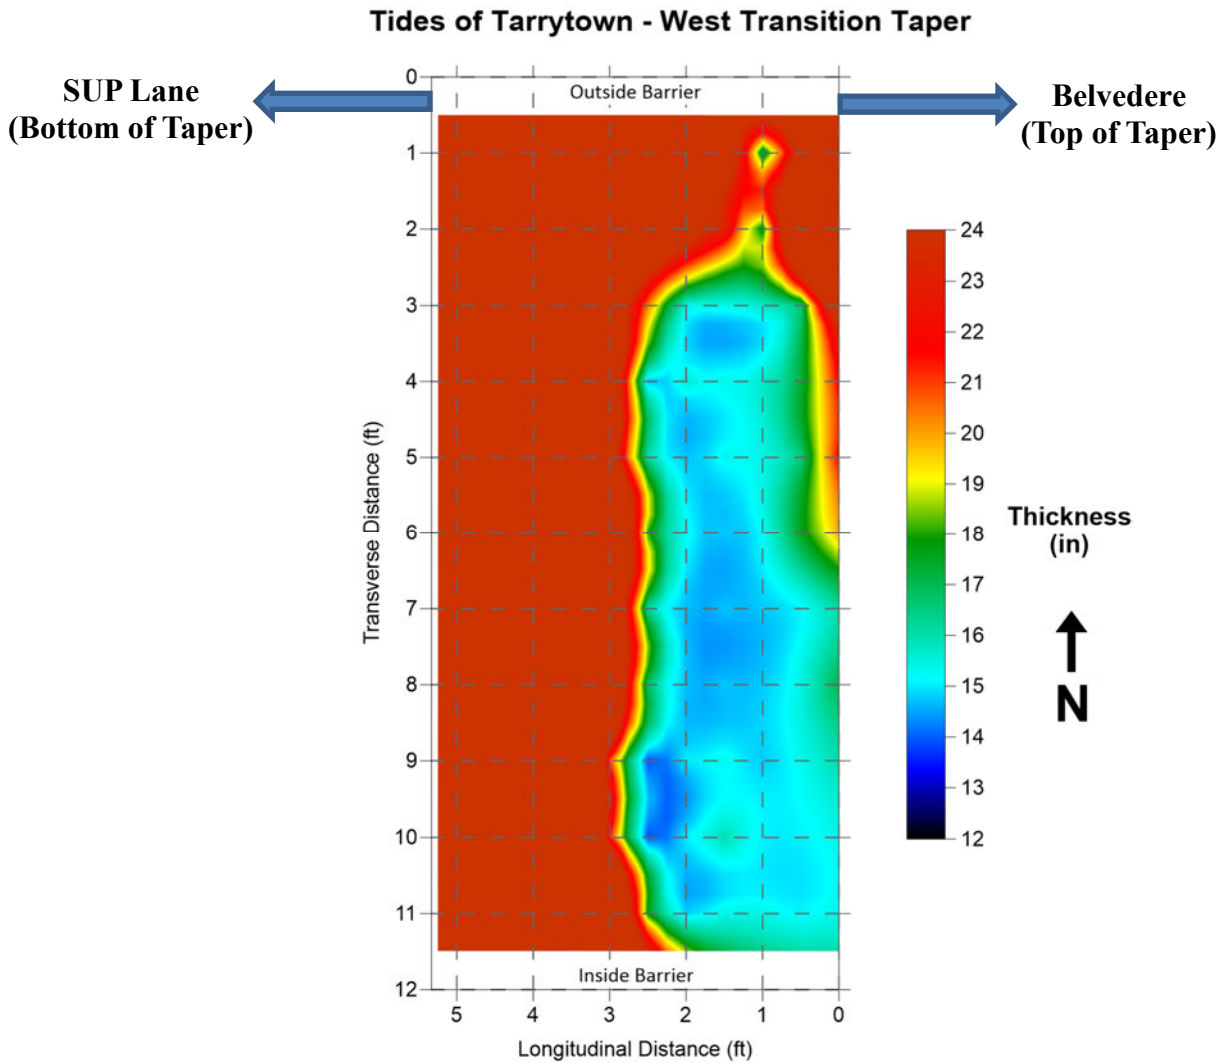
Figure 14. S³-IE Results of Tides of Tarrytown Belvedere #6 West transition taper X = 0 (right) is at the top of the taper, Y = 0 (top) is at the North outside barrier wall. The red areas (increased apparent thickness due flexural resonance from the debond) indicate the approximate area of significant delamination.
